INDOOR AIR QUALITY REASSESSMENT

**James Clark Elementary School
65 Oxford Street
Agawam, Massachusetts**

Prepared by:
Massachusetts Department of Public Health
Bureau of Environmental Health Assessment
Emergency Response/Indoor Air Quality Program
November 2003

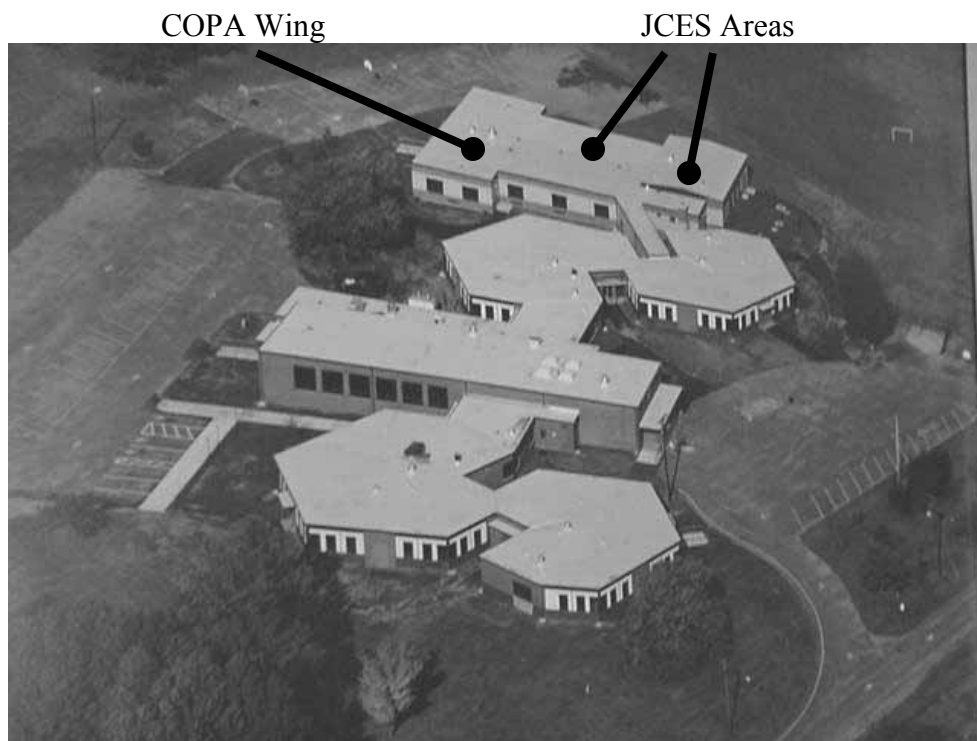
Picture 1

The JCES is a one-story brick building constructed in 1957. Additions were made in 1998 and 2001. From an aerial photograph, it appears that the JCES consists of seven distinct wings (Picture 1). The school contains general classrooms, library, offices, gym, cafeteria and kitchen. Windows in the JCES are openable. The 2001 addition included a wing that houses the Collaborative Program for Children with Autism (COPA). COPA is not part of the Agawam Public School system and is not included in this indoor air quality assessment.

Aerial View of JCES (All Non-Highlighted Wings Contain JCES Facilities)

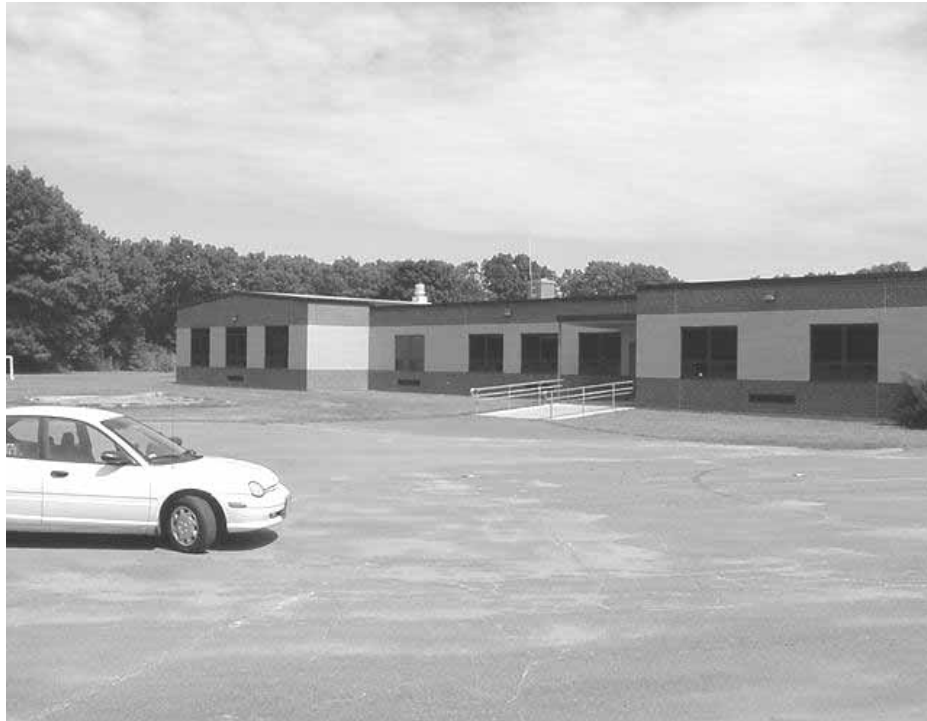
Picture 2

Building staff provided a theory that the high water table around the building was a contributing source of moisture in the building. As discussed, Mr. Feeney returned in mid summer to examine the school grounds. The grounds surrounding the new wing and COPA were free of standing water (Pictures 2 and 3). Conditions within the hallway and classrooms with reported moisture accumulation were also observed. In the experience of BEHA staff, moisture migrating through slab would degrade adhesive in contact with the cement producing loose floor tiles. In addition, cracks and/or uneven floor surfaces due to cement degradation would also be present. No loose floor tiles, cracks or uneven floor surfaces were found in hallways or classrooms, indicating that groundwater penetration through the slab was unlikely as a source of moisture in this area.

Rear Parking Lot near COPA Wing (Taken July 31, 2003, 2:19 PM)

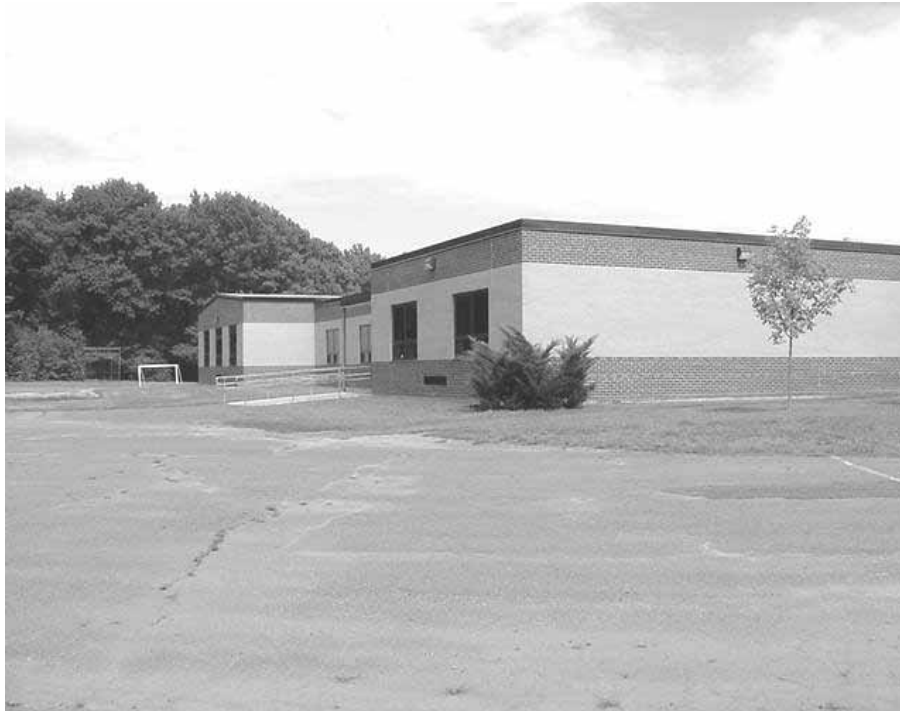
Picture 3

Another View Of Rear Parking Lot, near COPA Wing (Taken July 31, 2003, 2:22 PM)

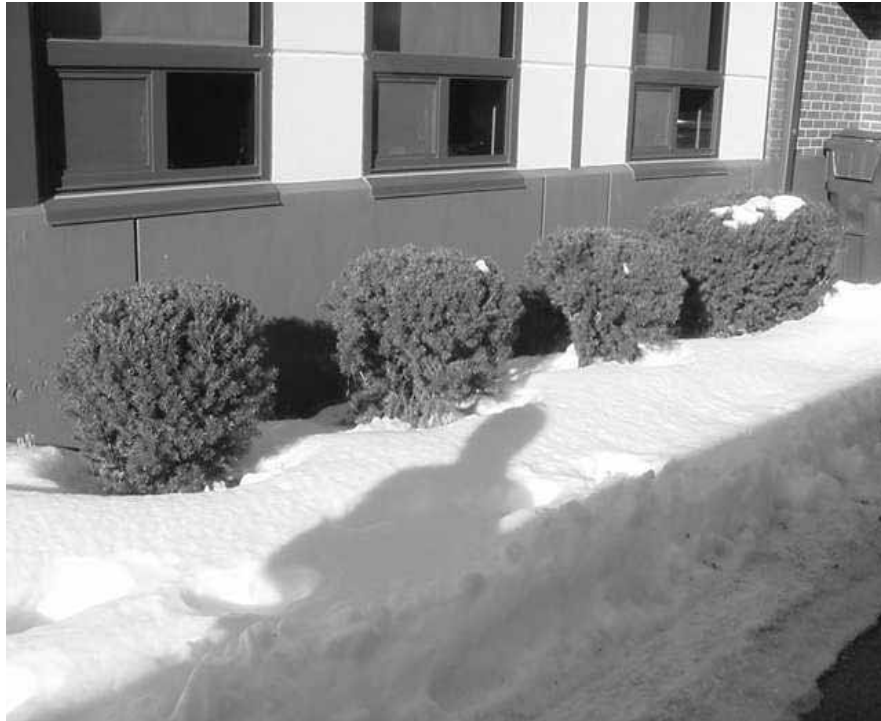
Picture 4

Shrubbery and other plants exist in close proximity to foundation walls (Picture 4). The growth of roots against exterior walls can bring moisture in contact with wall brick and eventually lead to cracks and/or fissures in the below ground slab. Over time, this process can undermine the integrity of the building envelope and provide a means of water entry into the building via capillary action through foundation concrete and masonry (Lstiburek & Brennan, 2001).

Shrubbery near Exterior Wall of Building
